The Historic Gingerbread House

Major renovations are underway

The Casita de Lemos ("Gingerbread House"), eligible for the National Register of Historic Places, was built in 1941 by artist Pedro de Lemos (1882-1954), long time curator of the

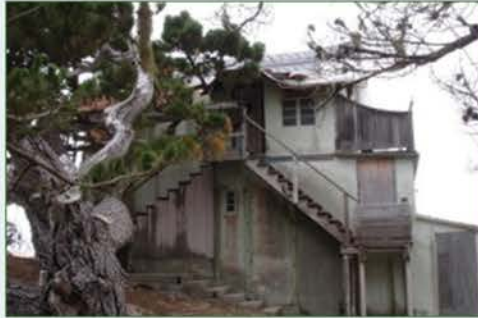
"Before" showing the deteriorated condition.

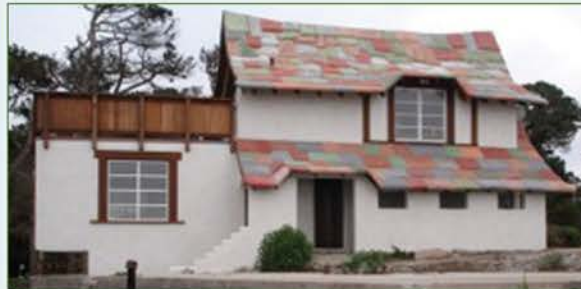
"After" the new exterior. Interior work is still needed.

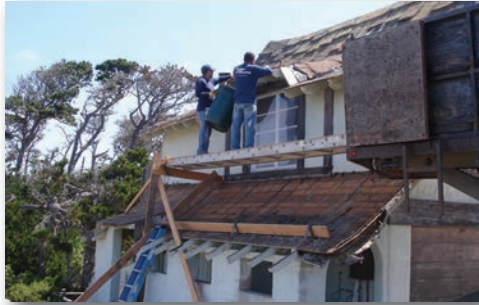
Eleven tons of concrete tiles were removed from the roof

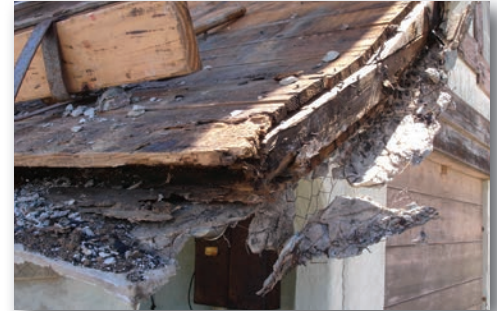
The first mystery was encountered after removal of eleven tons of concrete from the roof. Without applying the normal layer of waterproof roofing paper, Pedro nailed chicken wire directly to the roof decking and then applied concrete up to 4" thick. Much of the decking had rotted away. The mystery: what was holding up the roof?

Much of the roof decking had rotted away (Without applying the normal layer of waterproof roofing paper, Pedro had nailed chicken wire directly to the roof decking)

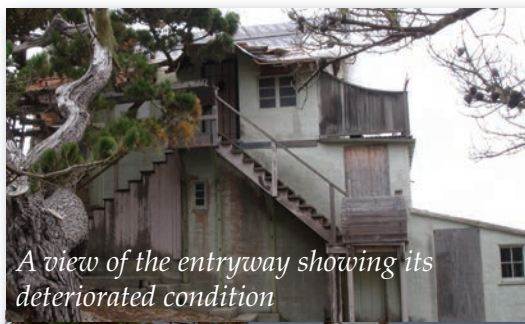
A view of the entryway showing its deteriorated condition

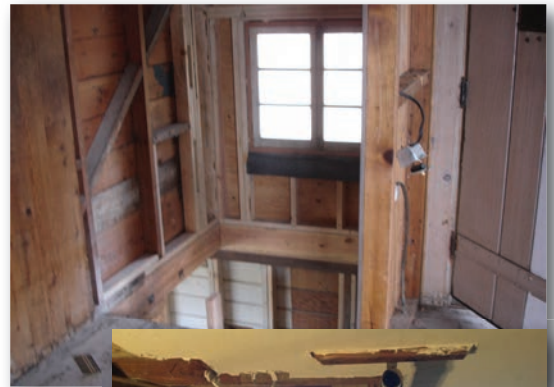
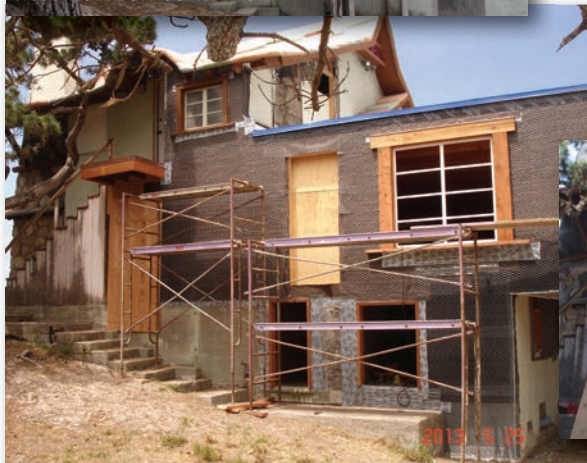
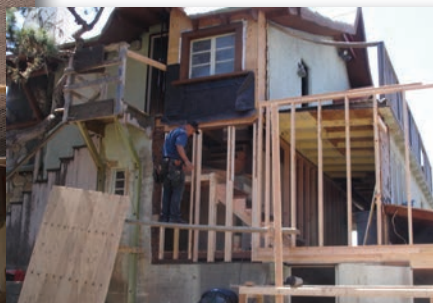
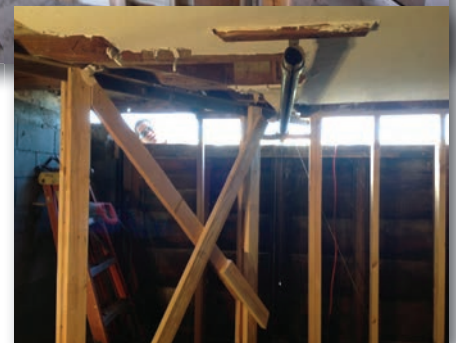
Much of the interior work is yet to be completed

Entryway repairs
