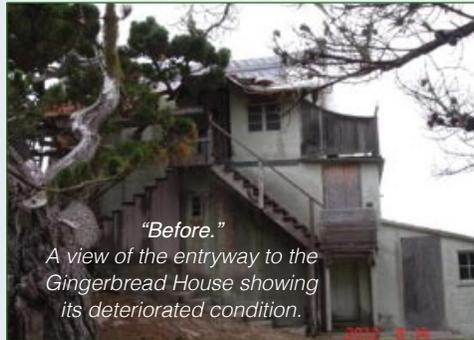
*"Before."  
A view of the entryway to the  
Gingerbread House showing  
its deteriorated condition.*

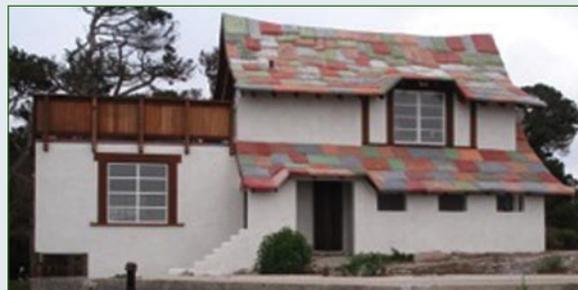
*"After" the new exterior. Interior work is still needed.*
