The Historic Gingerbread House

Major renovations are underway

The Casita de Lemos ("Gingerbread House"), eligible for the National Register of Historic Places, was built in 1941 by artist Pedro de Lemos (1882-1954), long time curator of the

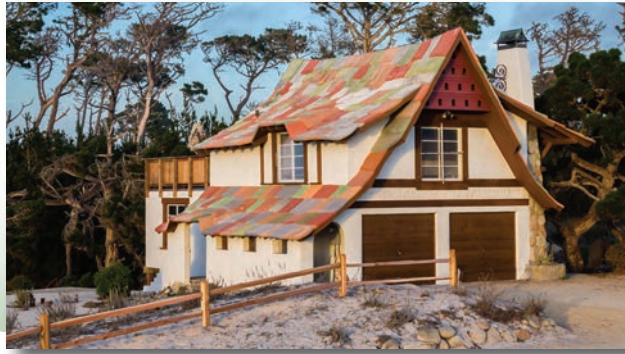
Stanford Art Museum and editor-in-chief of School Arts Magazine. A new roof and exterior renovation has stopped further water damage, but much work is still needed.
